***Historical channel change on the
Upper Gila River, Arizona and New
Mexico in response to anthropogenic
modifications and extreme floods***

U.S. Department of the Interior
Bureau of Reclamation

Upper Gila River Fluvial Geomorphology Study

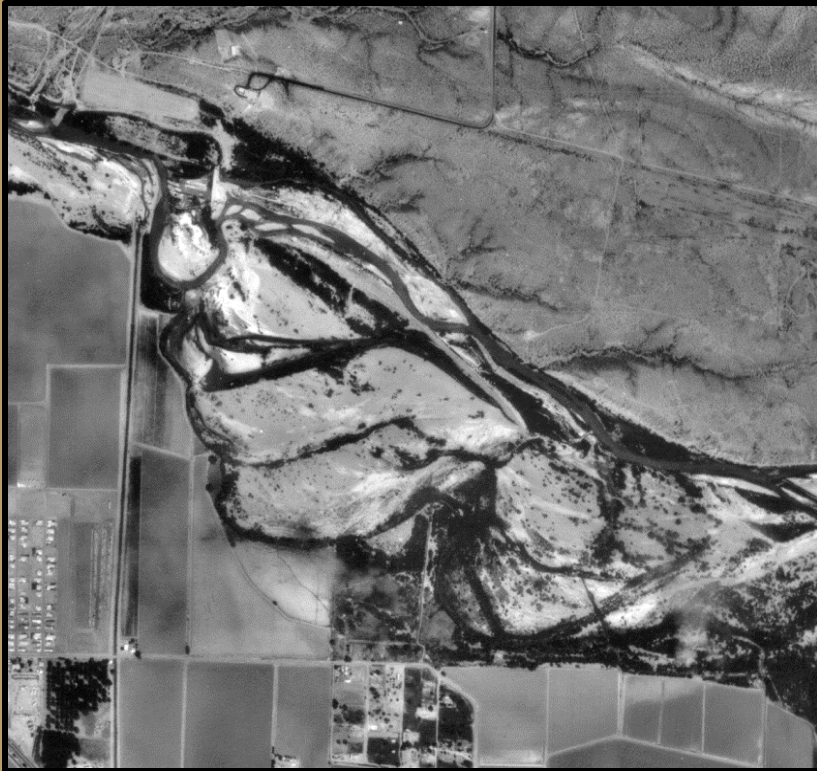
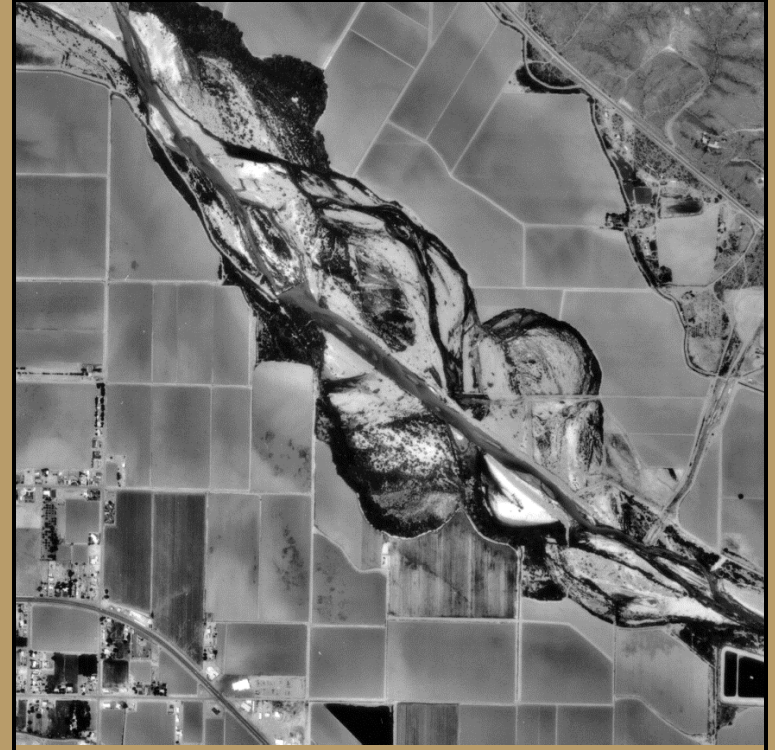
***Scalloped meander scrolls along
margins of diversion structures***

***Right angle bends in alluvial reaches
with no apparent geologic control***

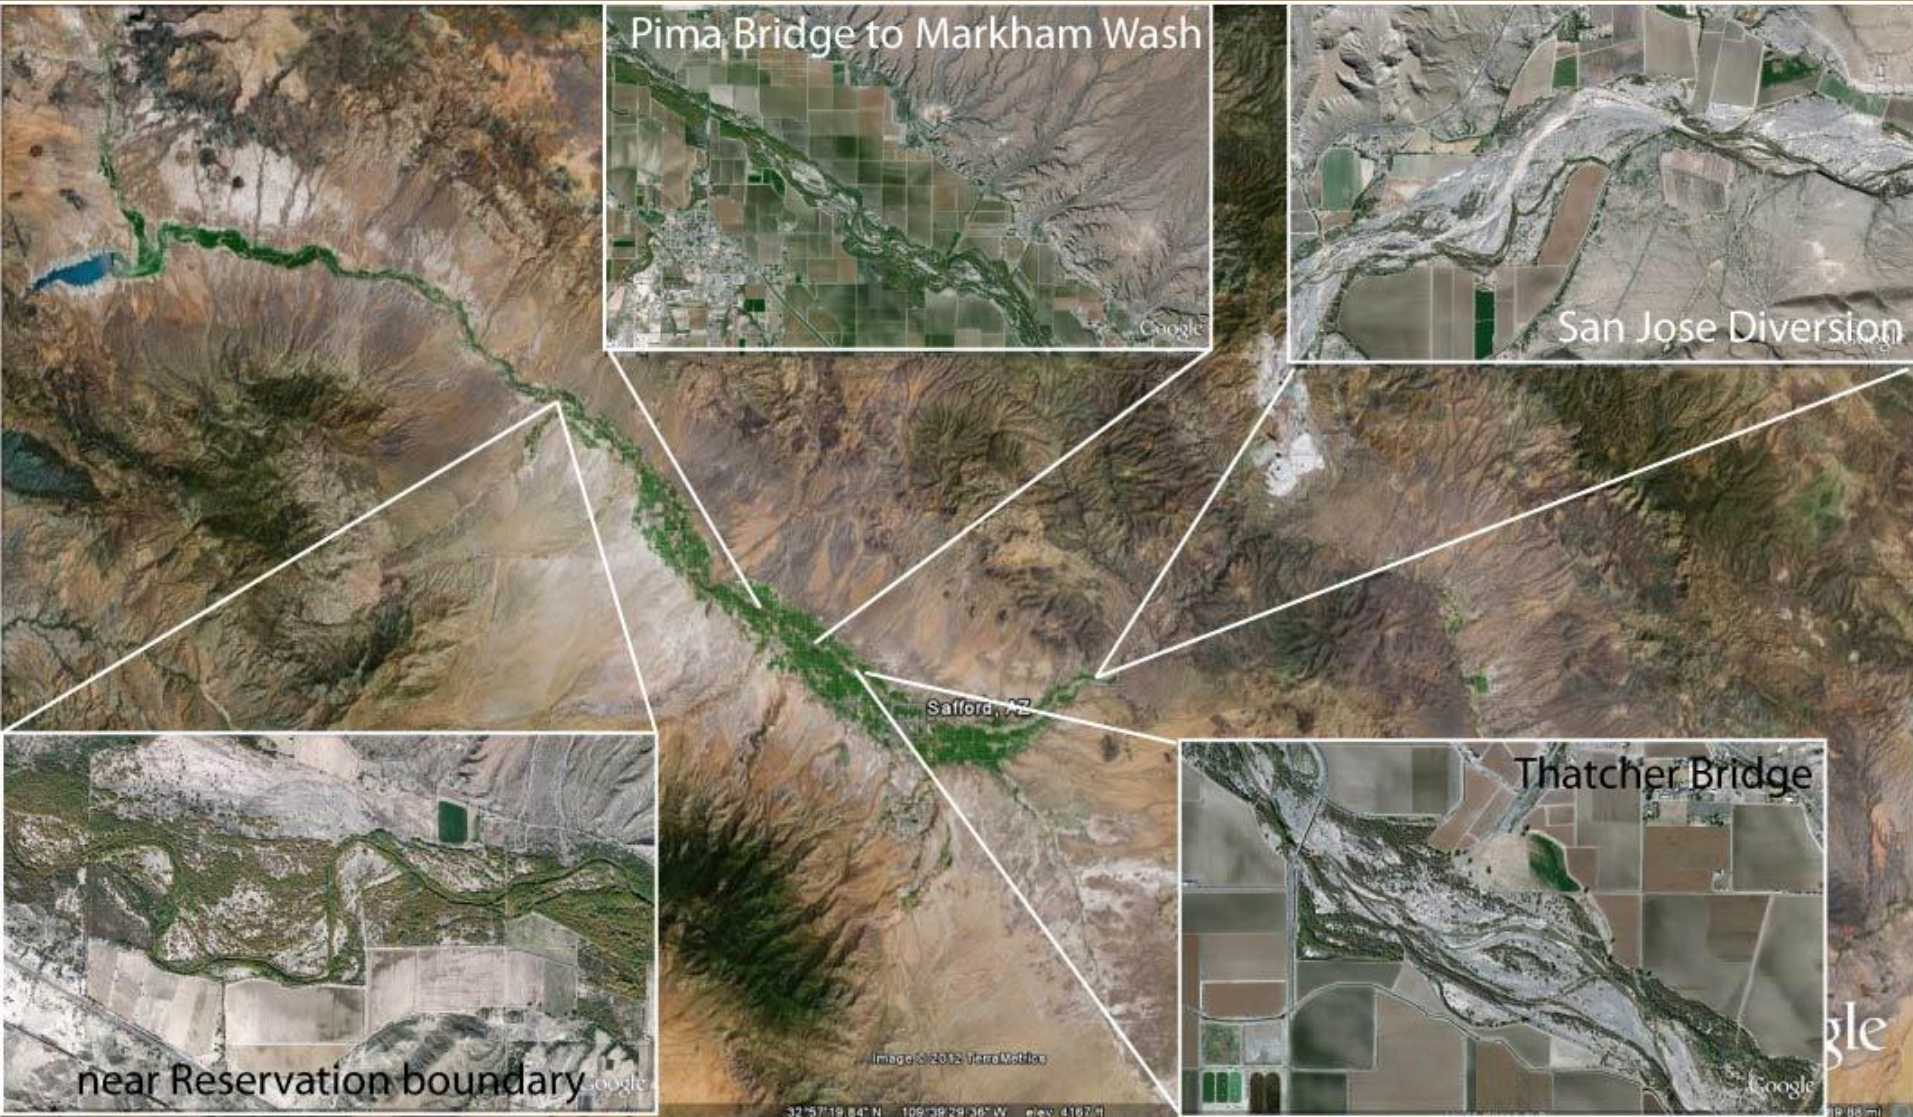
Areas of greatest change: Safford Valley

- Thatcher Bridge to Smithville diversion
 - Flow redirection following levee breach in channelized section upstream of Smithville Div.
 - Flow redirection by diversion dam and levees
 - Erosion of alluvium upstream of bridge

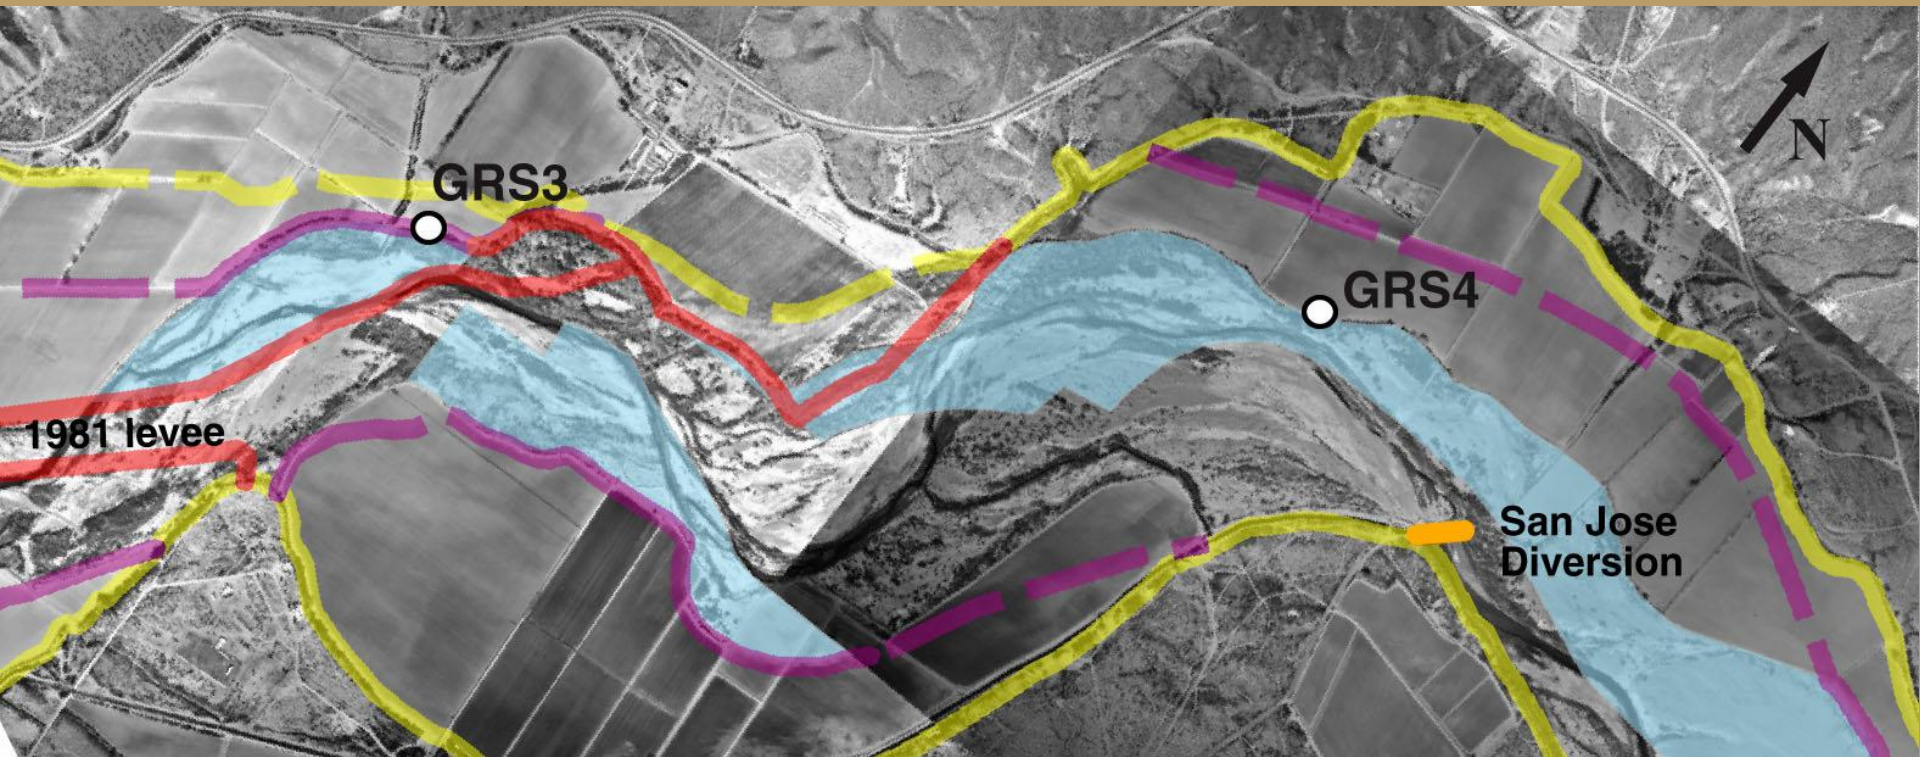
- **San Jose Diversion**

- Channel widening
- Flow redirection downstream of diversion structure
- Propagation of lateral erosion

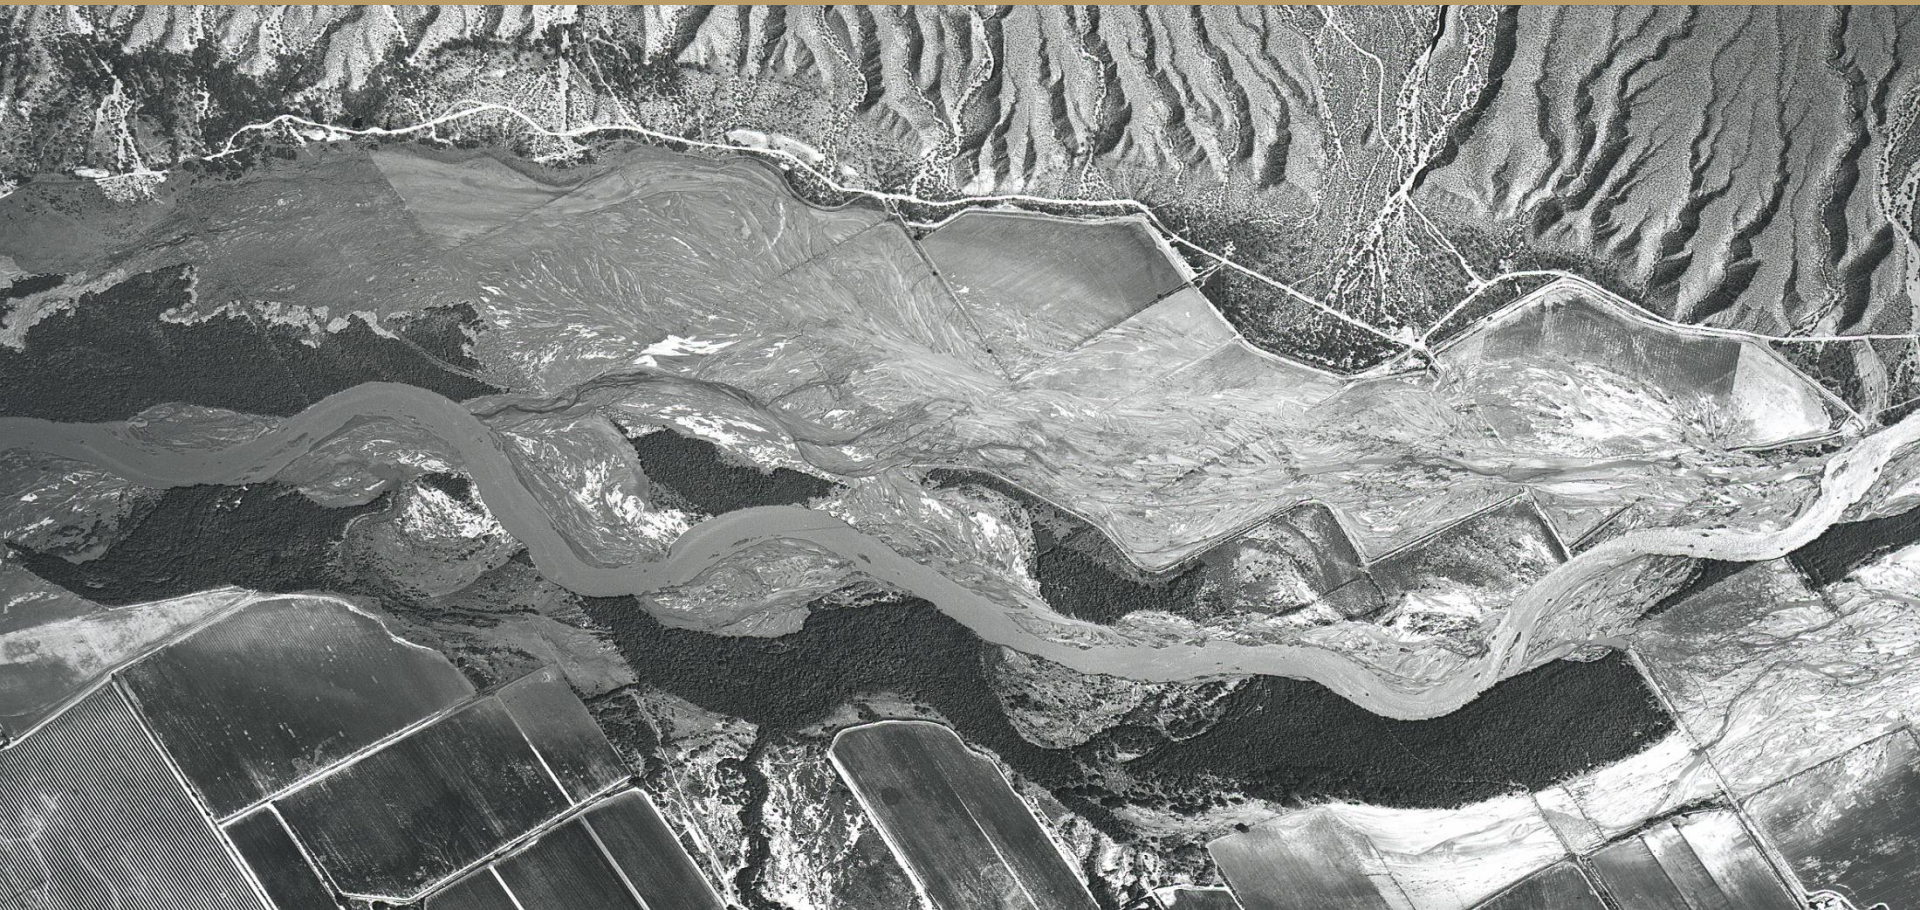
- **Fort Thomas Bridge**

- Levee breach

- Isolation of floodwaters by vegetation, prevented water from reentering channel downstream

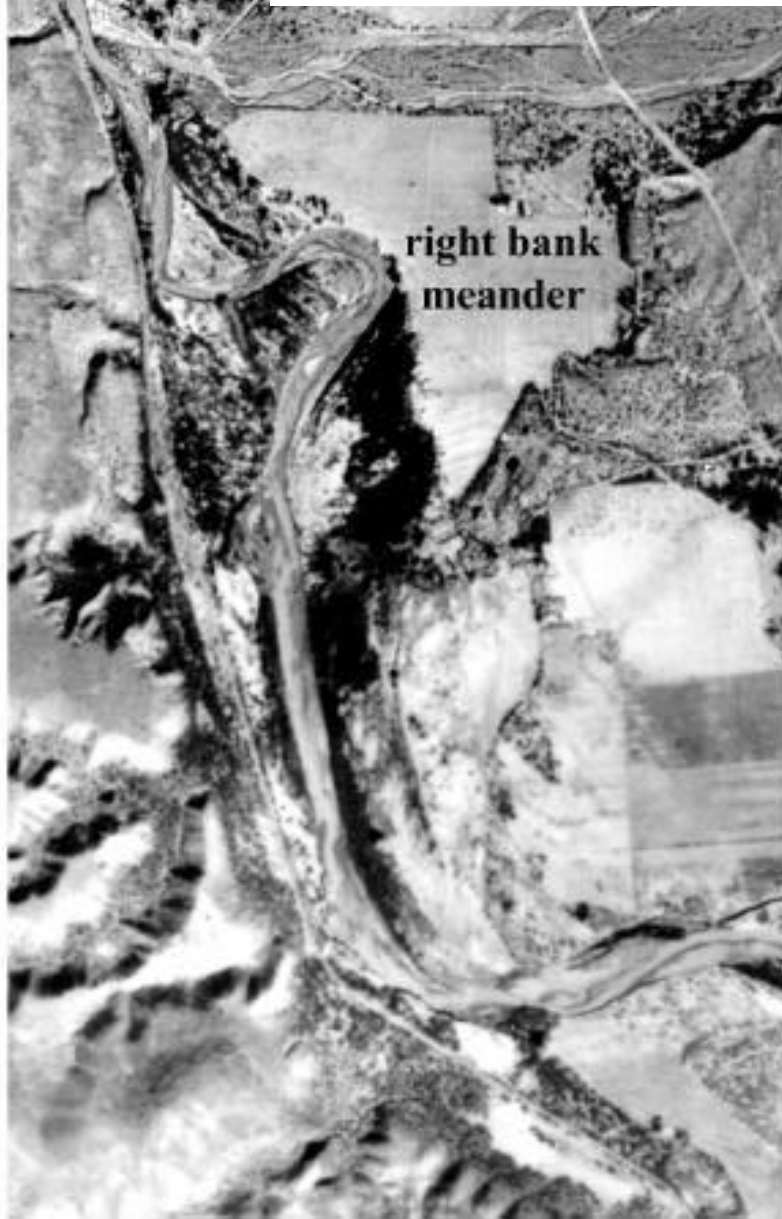
(a) 1935

Apache Grove/Kaywood Wash area

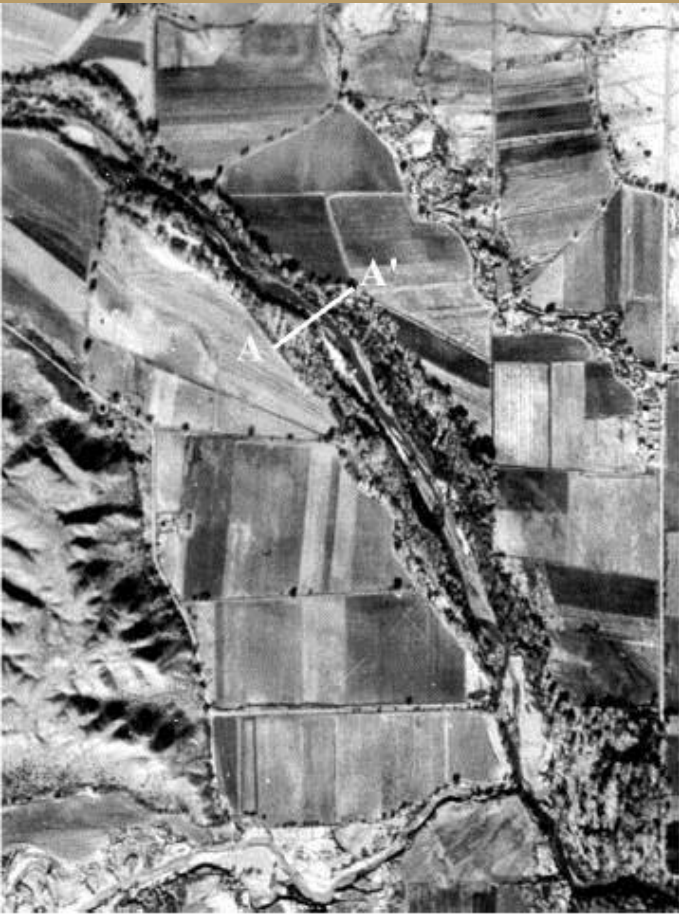
1935

Railroad wash area

- **Railroad Wash area**

- Levee breach, flow redirection, creating scalloped features
- Continued erosion behind levee
- Erosion followed previous channel paths

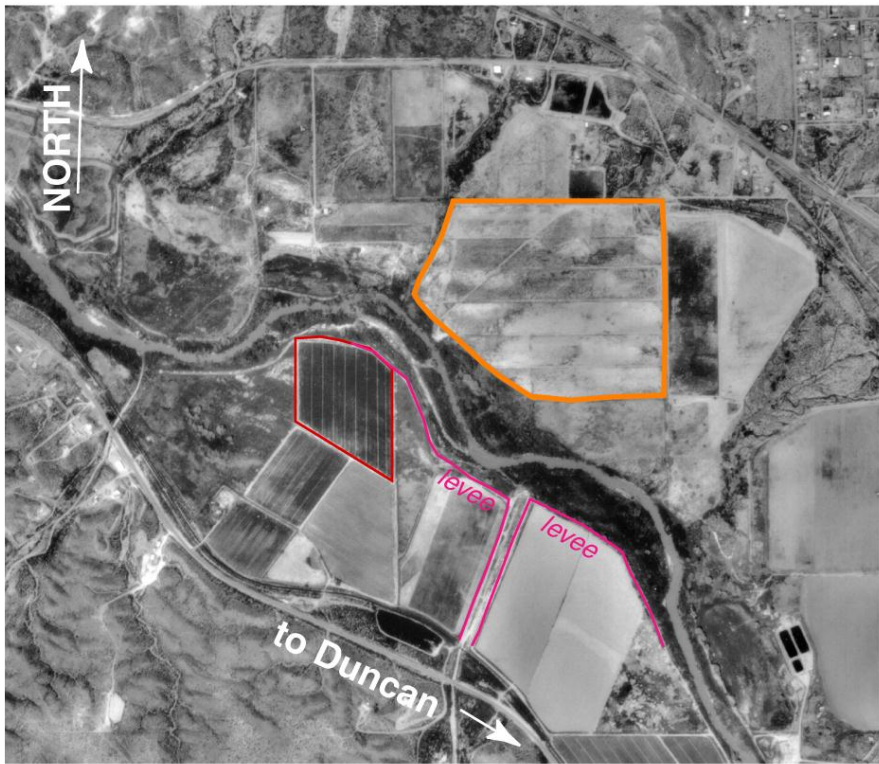
March 14, 1992

Gila River near Duncan, AZ

Effects of the 1993 and 1995 floods:

Red: erosion of floodplain around outside bends

Green: deposition behind levees

Pink: damage/destruction of flood control structures

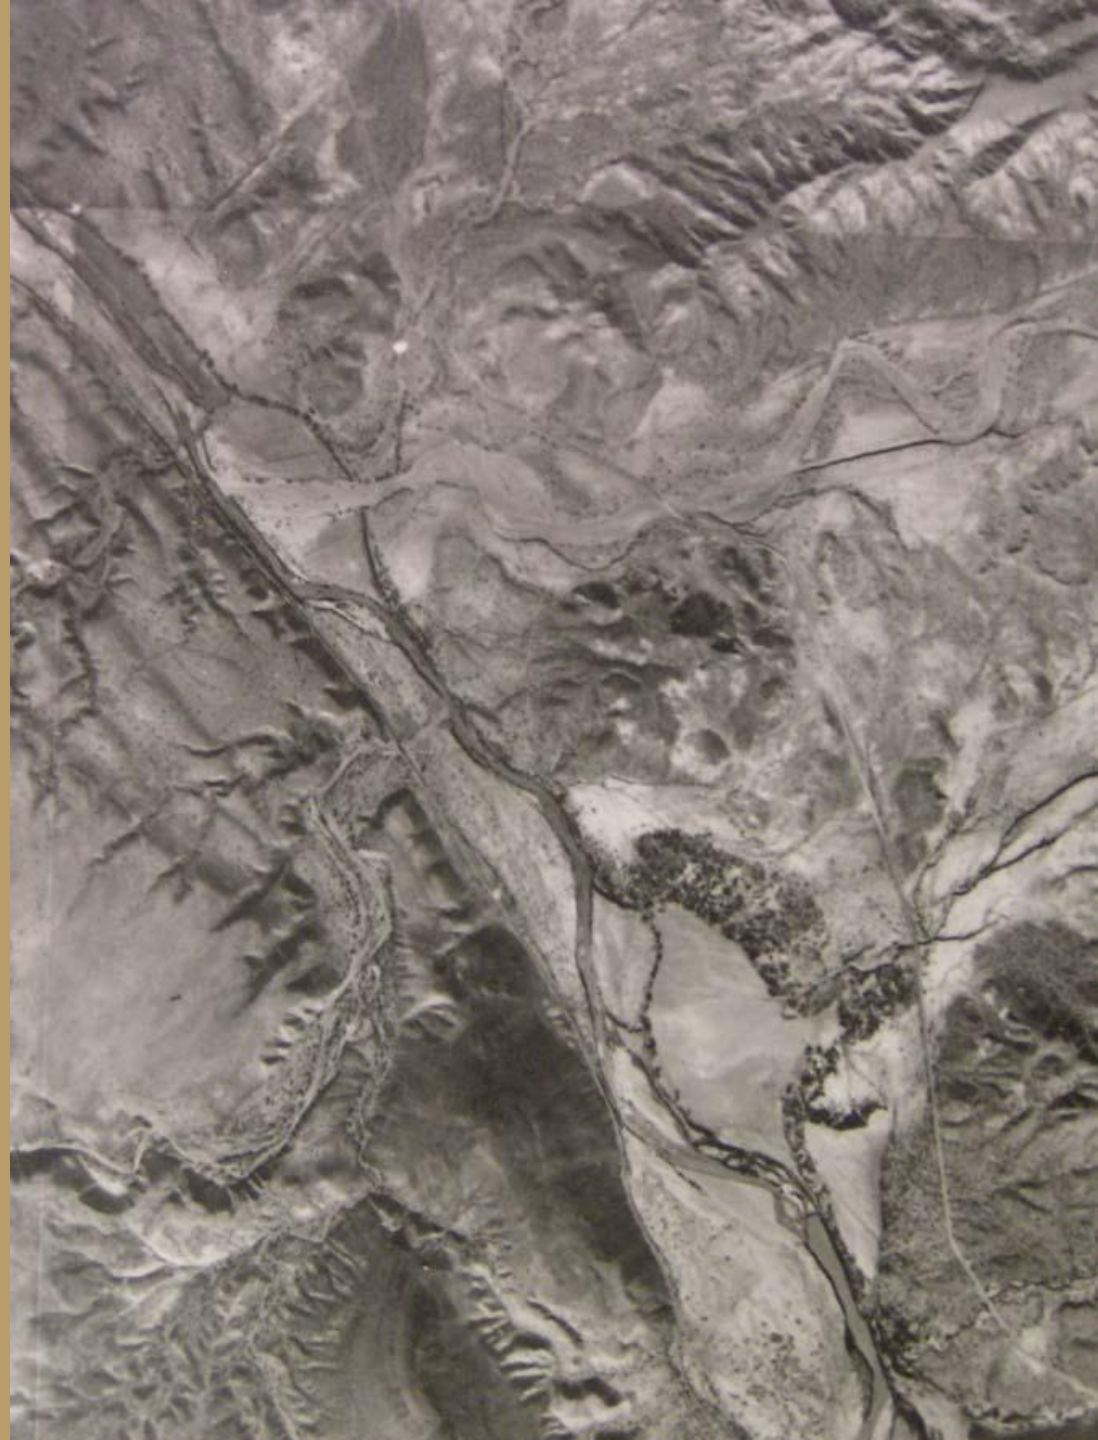
- **Influence of alluvial fans**

- Restricts channel width, expansion zones u/s and d/s of fan feature
- Control on location of channel
- alternating channel position in areas of multiple tributaries

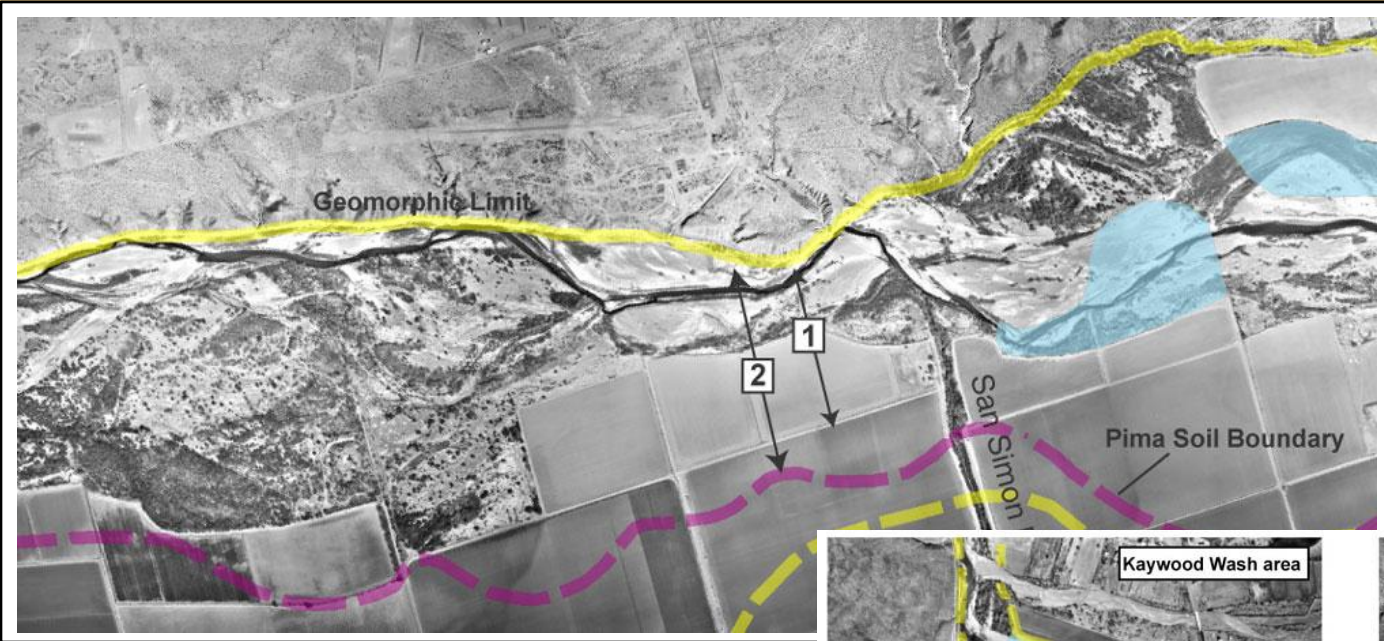
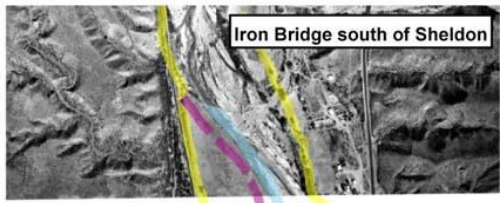
— = approximate location of levees within the Gila alluvium
